METALS HANDBOOK

VOL. 9
FRACTOGRAPHY AND ATLAS OF FRACTOGRAPHY

8th EDITION

Fractography and Atlas of Fractographs

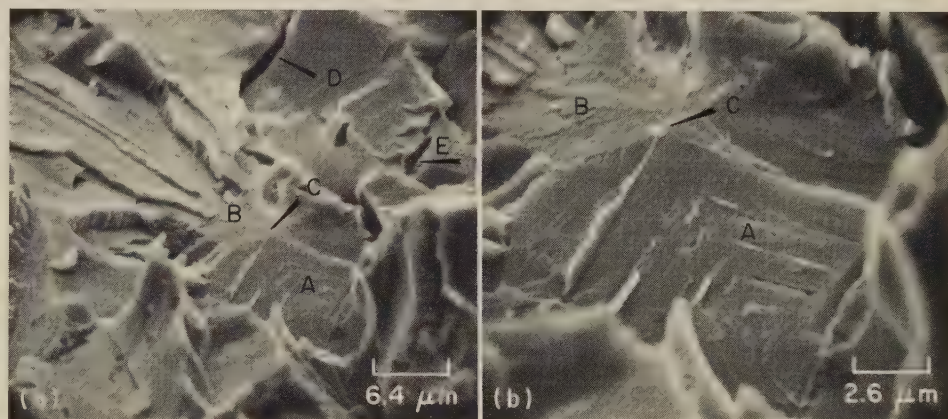
SEM fractographs

Grain A shows two well-defined sets of feathered tongues that are approximately orthogonal. A small carbide particle, C, at the boundary of grains A

and B initiated the local cleavage crack through the surrounding grains. Secondary cracks are at D and E. Note succession of cleavage steps in grain B.

Fig. 2. Tongues in a second area of cleavage of the 1040 steel specimen of Fig. 1, at the same 40° tilt. The same area is shown in both fractographs, but at different magnifications.

Cleavage-Crack Origins. Some of the main features to be looked for in a cleavage fracture include: (a) the origin of the main crack, (b) the origins of secondary cracks, and (c) the local directions of crack propagation. In Fig. 2(a) and (b), a well-defined origin is evident at C, at a carbide particle at a grain boundary. From the particle, which is small (about 1 micron in diameter), the crack propagated through the surrounding grains by cleavage. The propagation in the grain at B is typical of the type of cleavage where the crack propagates along different levels and behaves as if the grain were made up of layers. There is also a wide-open secondary crack, at D, in the upper part of Fig. 2(a), indicating the presence of cracking normal to the main fracture plane.

In grain A in Fig. 2, below the origin, are well-defined, feathered tongues, which were formed by fracture along microtwins. Tongues are sometimes associated with secondary microcracks. The tongues intersect the main cleavage plane along $\langle 110 \rangle$ directions. The fact that the two

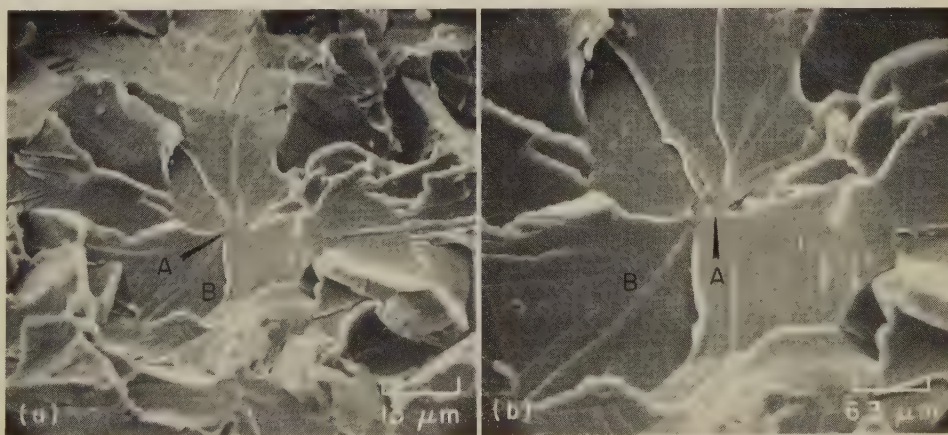
SEM fractographs

Cleavage spread in several directions from fractured carbide particle, A, at junction of four grains. Cleavage features differ from grain to grain, with river patterns visible in some and tongues in others.

River-pattern lines in grain B are attributed to interaction of local screw dislocations with cleavage plane. Height of steps increases in direction of crack propagation, to the left and downward.

Fig. 3. A site of cleavage-crack nucleation in the fracture surface of the 1040 steel specimen of Fig. 1 and 2, at the same 40° tilt to the electron beam. The same area is shown in both fractographs, but at different magnifications.

In Fig. 3(a) and (b) is another example of crack initiation at, and propagation from, a fractured carbide particle (A), at a junction of four grains. The fracture features in adjacent grains differ, being either tongues or well-defined river patterns. The river-pattern lines shown in grain B, emanating from the origin, are attributed to the presence of screw dislocations threading through the cleavage plane. Screw dislocations result in an increase in the height of river-pattern steps as a crack propagates. The density of river patterns has been related to the density of dislocations and to the degree of cold work present in the grain before cleavage occurs. The river patterns in Fig. 3 are difficult to see and to identify; in order to increase the contrast of faint river patterns, it is recommended that the fracture surface be shadowed with an extremely thin film of gold to enhance the edges of the river-pattern steps.

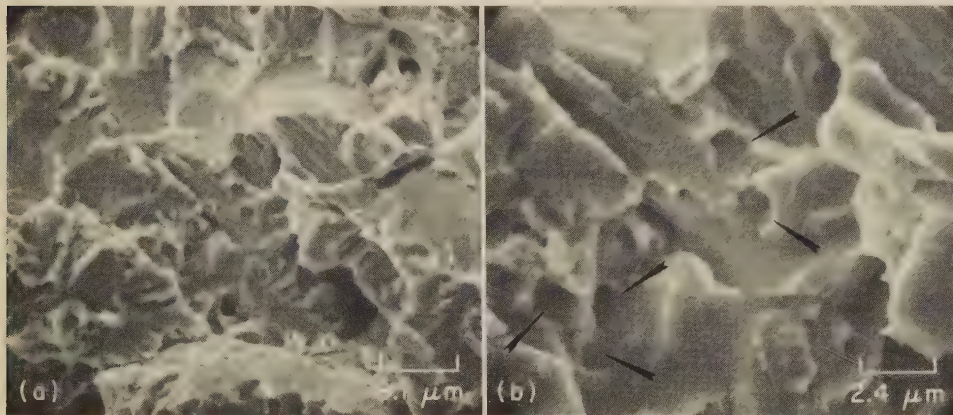
SEM fractographs

The small cleavage facets in martensite platelets contain river patterns and are separated by tear ridges. Shallow dimples, marked by arrowheads, are also visible. Direction of crack propagation is from

bottom to top in each fractograph. The specimen was heat treated at 843°C (1550°F) for 1 hr, oil quenched, and tempered at 427°C (800°F) for 1 hr. Fracture was by Charpy impact at -196°C (-321°F).

Fig. 4. Quasicleavage in the surface of an impact fracture in a specimen of 4340 steel. The same area is shown in both fractographs, but at different magnifications.

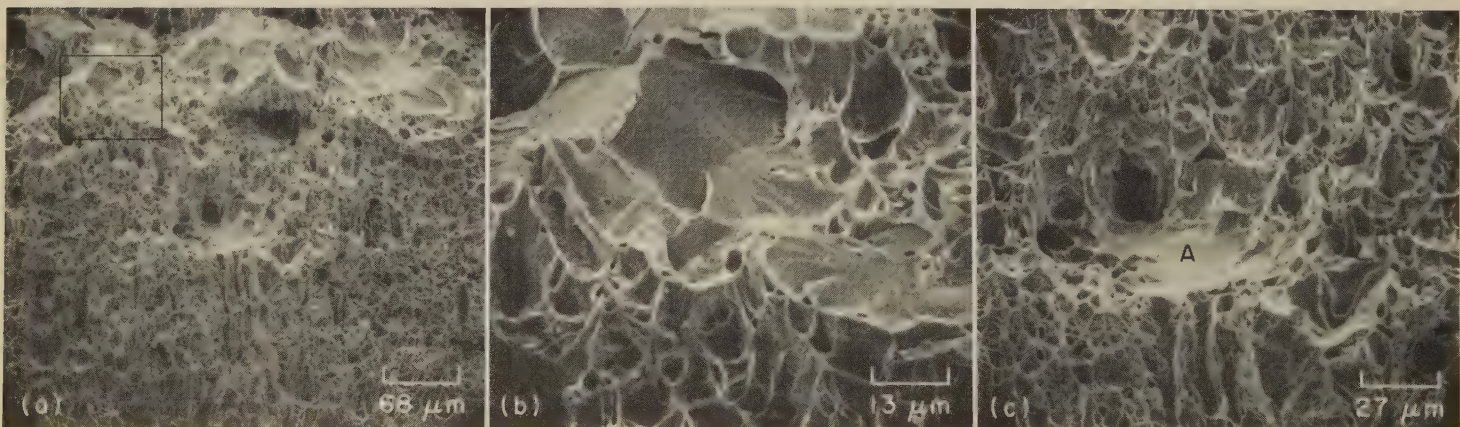
SEM fractographs

The machined notch of the specimen was below the region shown in (a). The over-all direction of crack propagation was upward. Although equiaxed dimples predominate, certain grain orientations near the top of (a) were unfavorable for ductile fracture by microvoid coalescence and local cleavage occurred, as shown in detail in (b), which is a higher-magnification view of the

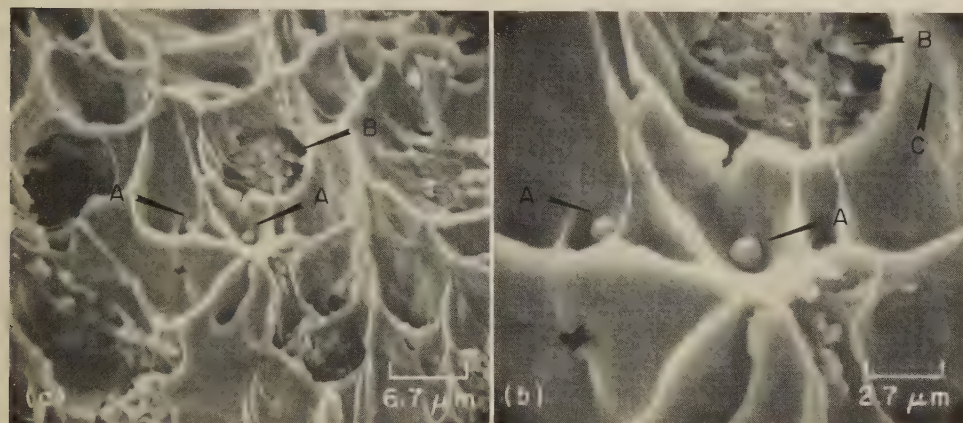
SEM fractographs

The dimples at the center of these views were initiated at an interface between the matrix and globular inclusions (marked A), which probably are sulfide, aluminum oxide or complex silicate particles.

Fig. 6. Two different types of dimple-initiation sites, as exhibited in views at two magnifications of another area of the Charpy impact fracture shown in Fig. 5, at the same 30° angle of tilt to the electron beam

Identification of ductile fractures with a scanning electron microscope is simple, because dimples are easily distinguished from cleavage, fatigue, and intergranular-fracture features. Microvoids are initiated at interfaces between the matrix and particles such as carbides, precipitates and inclusions, and also at imperfections such as microporosity and microcracks. They grow under the triaxial stress conditions ahead of the crack tip and expand until they coalesce to leave behind on the fracture surface the familiar hemispheroidal cavities that are known as dimples. The shape and depth of dimples, or microvoids, can be related to the size of, and spacing between, initiating particles, to the condition of applied stress (tension, shear or torsion), and to the fracture toughness of the specimen. Figure 6(a) shows a ductile-fracture sur-

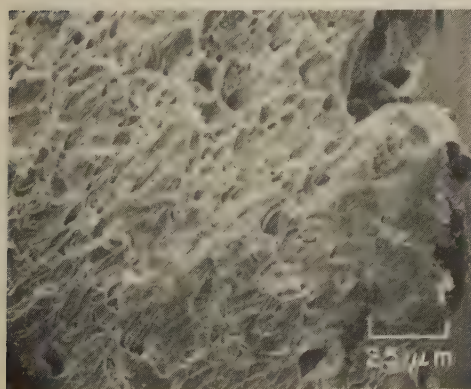
SEM fractograph

400×

The free edge of the shear-lip zone is the vertical margin at the right. The dimples are elongated, and their rounded ends point in the same direction. The mating surface of this shear-lip zone would show similar elongated, parallel dimples, but their rounded ends would point in a direction opposite to that shown here.

Fig. 7. Shear dimples in the shear-lip zone of the Charpy impact fracture in 1040 steel shown in Fig. 5

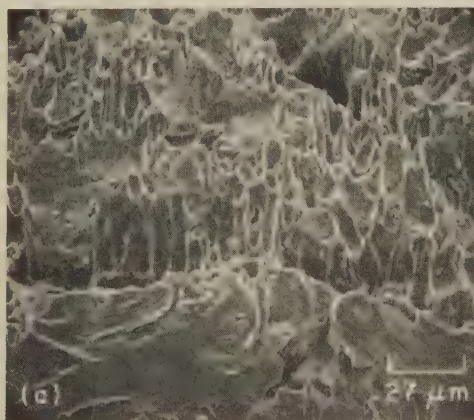
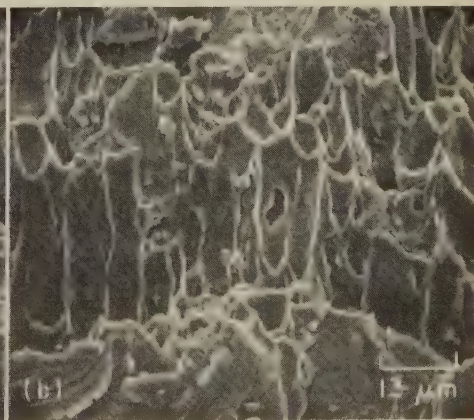
SEM fractographs

Tear dimples resemble slim parabolas and point toward the site of crack initiation at the notch root, which is shown in the lower third of these fractographs. Unlike shear dimples, the tear dimples on the mating surface of this fracture would point in the same direction — toward the notch.

375× (a); 750× (b)

Occasionally, when the over-all shape of the fracture surface is unknown, a comparison of the mating fracture surfaces to observe the relative directions of dimple orientation may be the only method of determining whether the dimples present were formed by shear or by tearing.

Tear dimples are formed by nonaxial stress conditions, such as those that exist in notched plane-strain fracture-toughness specimens and in drop-weight tear-test specimens. Nonaxial stress conditions are found also in the test where a wedge is forced into a notch (see Ref 13 in the list on page 92). The elongated microvoids that become tear dimples are formed in a narrow band just ahead of a well-developed crack front, such as the tip of a fatigue crack. Figure 8 shows the nature of crack propagation from the root of the notch in a Charpy impact specimen. The lower third of the fractograph shows the machined surface at the root of the notch. The fracture originated at this highly distorted surface during the Charpy test. One major crack formed from many crack nuclei, and the propagation of this crack took place by microvoid initiation, growth and coalescence. Coalescence of the microvoids resulted from tearing or opening of the crack under the applied load. This action formed the elongated dimples known as tear dimples, which have the appearance of parabolas pointing in the direction of crack initiation. On the mating surfaces of this fracture, the parabolas of the dimples are the same — on both sides, they point in the same direction, toward the site of crack initiation. Tear dimples are rare, which indicates that tensile tearing is not a predominant mechanism of fracture.

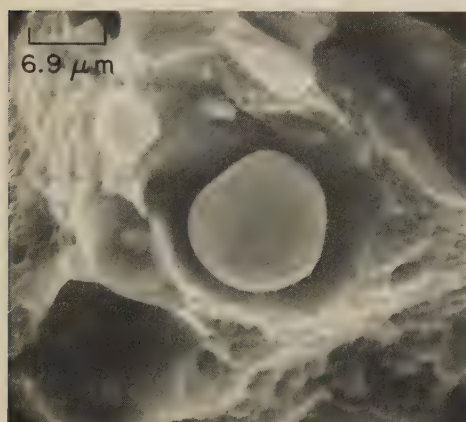
SEM fractograph

1440×

At center is a very large iron-rich inclusion, which rests within the large dimple it nucleated. In the surrounding surface areas are many extremely small dimples. The yield strength of this specimen was 517 MPa (75 ksi), and the hardness was Rockwell B 95.

Fig. 9. A fracture in aluminum alloy 7075-T6 showing a marked variation in size of dimples

of precipitate particles, dimples may exhibit a wide range of dimensions. This is shown in Fig. 9, in which a fracture surface in aluminum alloy 7075-T6 displays large dimples that are associated with large iron-rich inclusions (1 to 10 microns in diameter). In contrast, there is also a network of very small dimples, about a tenth to a fiftieth the size of the large dimples, resulting from microvoid initiation around the fine precipitates that strengthen this aluminum alloy.

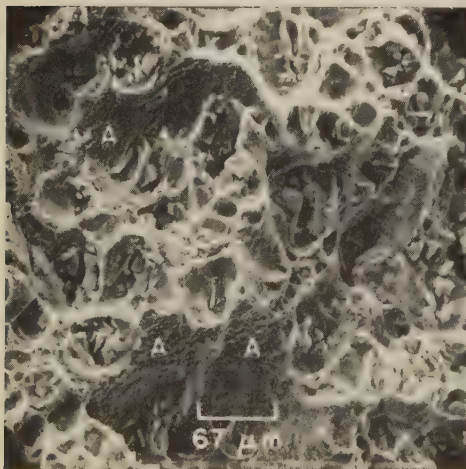
SEM fractograph

150×

Fig. 10. Fracture surface of an aluminum alloy 2024-T5 fracture-toughness specimen, showing a wide range in size of dimples

Another example of a wide range in dimple sizes is provided in Fig. 10, which shows the fracture surface of a fracture-toughness specimen of aluminum alloy 2024-T5. The moderately large dimples, which contain broken inclusions, are outlined by tear ridges, and they contrast sharply with the extremely fine dimples present on some of the steep slopes of the even larger dimples.

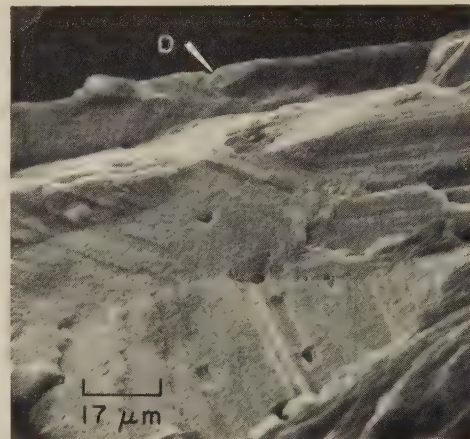
SEM fractograph

600×

The fracture origin is at O, near the top of the fractograph, in a free surface of the specimen. The change of orientation of the fracture plane from grain to grain is well demonstrated. Within a given grain, the fracture is along a {111}-type plane. The ridge patterns within each grain are parallel to the direction of crack propagation. Each ridge is probably in a <110> direction, which is the intersection of two {111} slip planes. The presence of inclusions does not affect the fracture path. Stage I of fatigue-fracture progress extended over 3 or 4 grains; stage II began at bottom right.

Fig. 11. Stage I of fatigue-fracture progress in a smooth (unnotched) specimen of aluminum alloy 2024-T3

and their propagation by slip-plane fracture, extending inward from the surface at approximately 45° to the stress axis. This stage is illustrated at a magnification of 600 diameters in Fig. 11 and 12.

The crack origin can best be found by first viewing the fracture surface at low magnifications from 25 to 100 diameters. In each grain the fracture surface is along a well-defined crystallographic plane (see Fig. 11), which should not be confused with a cleavage plane although it has the same brittle appearance. A stage I fracture never extends over more than a few grains (about 2 to 5) around the origin. There are usually no fatigue striations

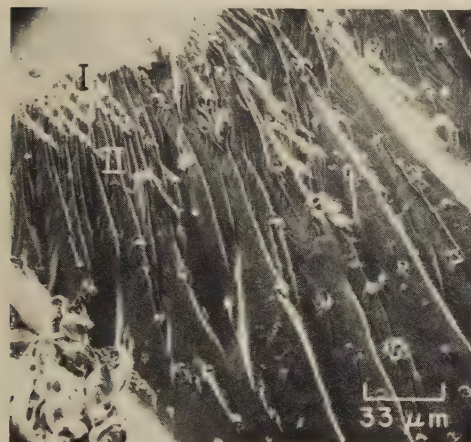
SEM fractograph

300×

The transition from stage I (upper left) to stage II is well defined. The presence of (Fe,Si)-rich inclusions did not affect the fracture path markedly. The inclusions, which were fractured, range from 5 to 25 microns in diameter. The stage II area shows a large number of approximately parallel fatigue patches containing very fine fatigue striations that are not resolved at this magnification.

Fig. 13. Transition from stage I to stage II of a fatigue fracture in a coarse-grained specimen of aluminum alloy 2024-T3

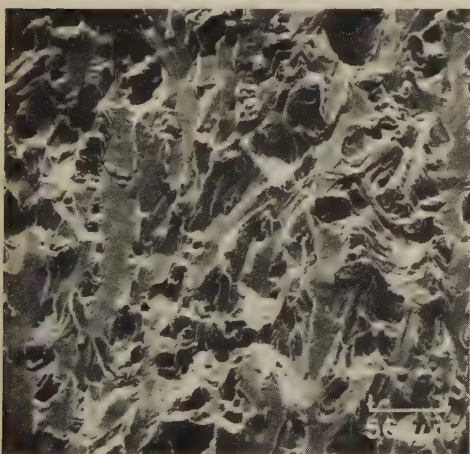
SEM fractograph

180×

The fracture surface is made up of facets, each facet corresponding to a specific grain, thus allowing the grain size to be measured. The orientations and levels of facets change from grain to grain. The presence of large inclusions results in local ductile fracture by microvoid growth. The crack-propagation direction is from bottom to top in this view.

Fig. 14. Stage II of a fatigue fracture in a fine-grained specimen of aluminum alloy 2024-T3 tested in dry air

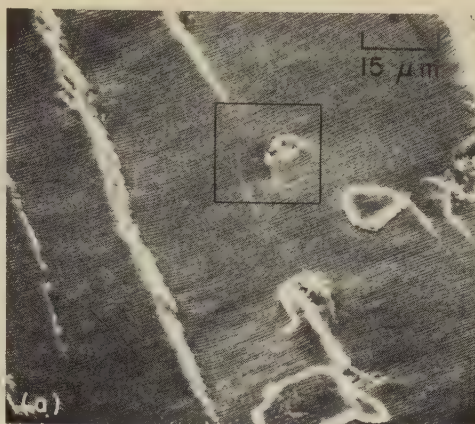
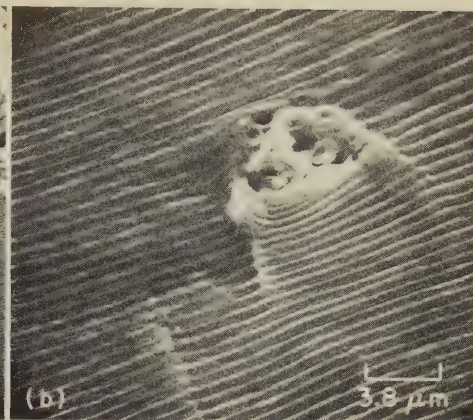
SEM fractographs

(a) The uniformity of the crack-propagation process is well illustrated. There was little or no interaction of the fracture process with the inclusion within the rectangle. The long ridges are believed to be high-angle steps at subgrain boundaries.

(b) Higher-magnification view of the region outlined by the rectangle in fractograph (a), showing

650× (a); 2600× (b)

the continuity of the fracture path through and around the inclusion. Fracture "wake lines" are visible and indicate that the direction of crack propagation was toward the lower right corner of the fractograph. These wake lines originate at the inclusion and run normal to the crack front in the direction of crack propagation.

Fig. 15. Ductile fatigue striations in aluminum alloy 2024-T3

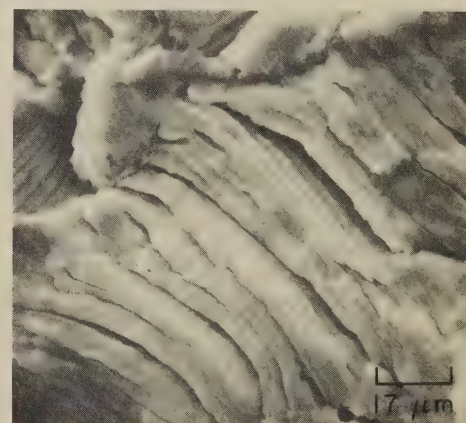
Fig. 17. Ductile striations in a fatigue fracture in aluminum alloy 2024-T3 that occurred at a high growth rate caused by a high range of stress intensity (ΔK) at the crack tip

At high growth rates (10^{-4} in. per cycle or more), a large plastic zone exists in front of the crack, which may cause extensive secondary cracking. Each secondary crack propagates as a fatigue crack, creating a network of secondary fatigue striations. The local crack direction, which is toward the upper right, may differ markedly from the over-all direction of crack propagation because of the chaotic nature of the fracture surface.

Figures 15, 16 and 17 present details of "ductile" fatigue striations in stage II of fracture progress in aluminum alloy 2024-T3. At high rates of crack growth (Fig. 17), the striations become wavy, with a rough front, and many secondary cracks are observed. In aluminum alloys tested in a corrosive environment (water or seawater), the striations form on crystallographic fracture planes and are called "brittle" striations (Fig. 18). Within each grain the fracture path associated with

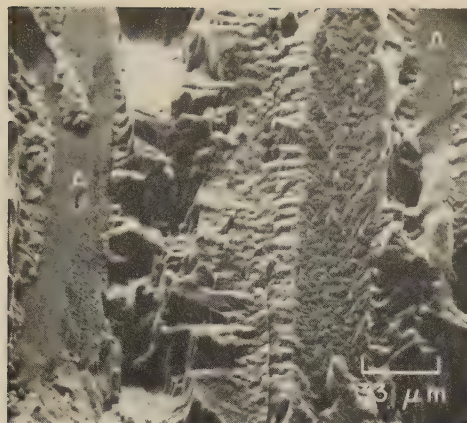
Fig. 18. Brittle striations in a corrosion-fatigue fracture in aluminum alloy 7075-T6

The presence of seawater at the crack tip changed the topography of the fatigue striations from ductile to brittle. Brittle striations indicate corrosion fracture in most aluminum alloys. The roughness of the fracture surface is the result of the crystallographic mode of fracture. Two patches of ductile striations are visible at A. Direction of crack propagation was from bottom to top in this view.

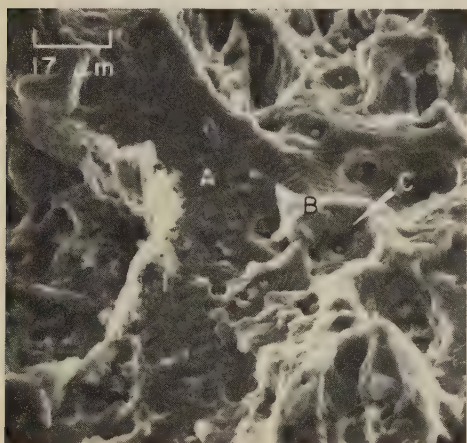
Fig. 19. Corrosion-fatigue fracture in aluminum alloy 7075-T6 that occurred at a high growth rate caused by a high range of stress intensity (ΔK) at the crack tip

Fracture shows brittle striations, such as at A, and tearing, such as at B, around dimples initiated by inclusions, such as at C. There are patches of ductile fatigue striations adjacent to the dimples. The chaotic nature of the fracture path is related to the large size of the plastic zone ahead of the crack tip.

corrosion fatigue looks like a cleavage plane. Because of the difference in orientation from grain to grain, part of the crack front will propagate in a ductile manner, creating alternate patches of ductile and brittle striations. At high rates of crack growth, transgranular corrosion fracture is accompanied by extensive dimple formation around large inclusions (Fig. 19).

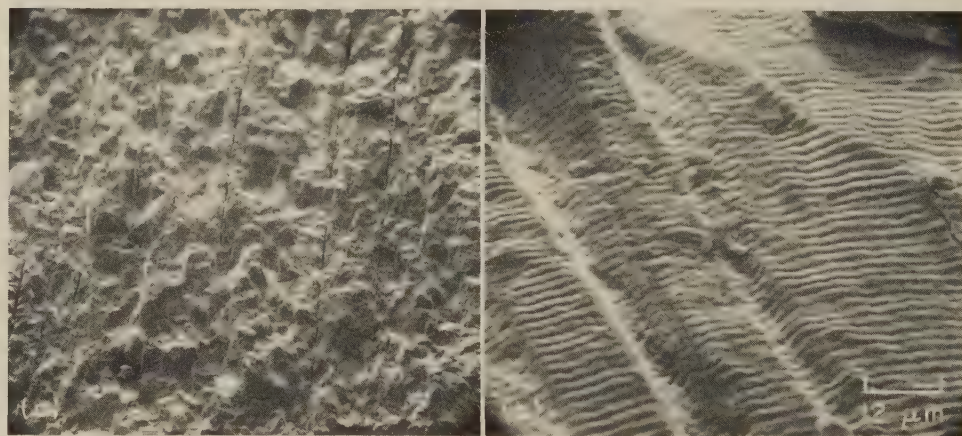
Fig. 20. Fatigue fracture in type 304 stainless steel tested at room temperature. The vertical secondary cracks in (a) are grain-boundary separations. The well-defined striations in (b) resulted from the planar slip characteristic of stainless steels.

In steels, fatigue striations that are formed at ordinary crack-growth rates are not always as well-defined as they are in aluminum alloys. Figures 20 and 21 show typical fatigue-fracture surfaces in type 304 stainless steel and in 18% Ni, grade 250, maraging steel. The striations that are formed at very low crack-growth rates (less than 5×10^{-6} in. per cycle)

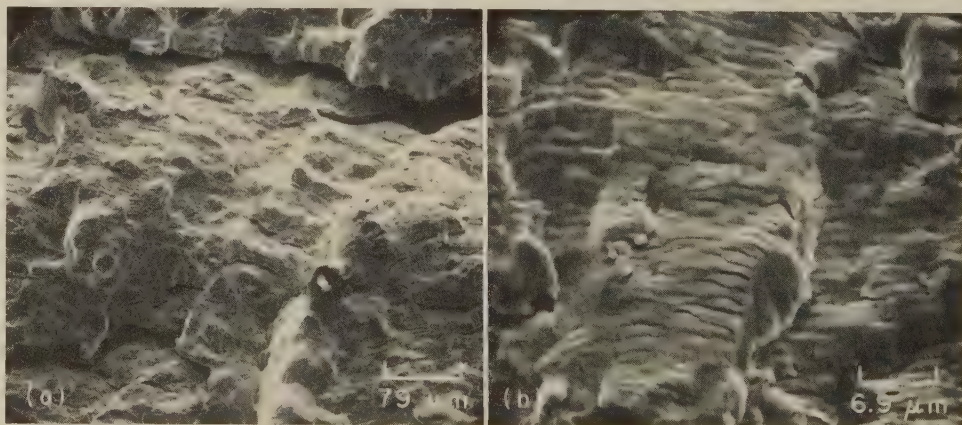
Fig. 21. Fatigue fracture in 18% Ni, grade 250, maraging steel tested at room temperature

Extensive secondary cracking can be seen in the lower-magnification fractograph (a), and is clearly evident in the one at higher magnification (b). Secondary cracks formed at the roots of many fatigue striations. The range of stress intensity (ΔK) at the crack tip was 76.9 MPa·m^{1/2} (70 ksi·in.^{1/2}).

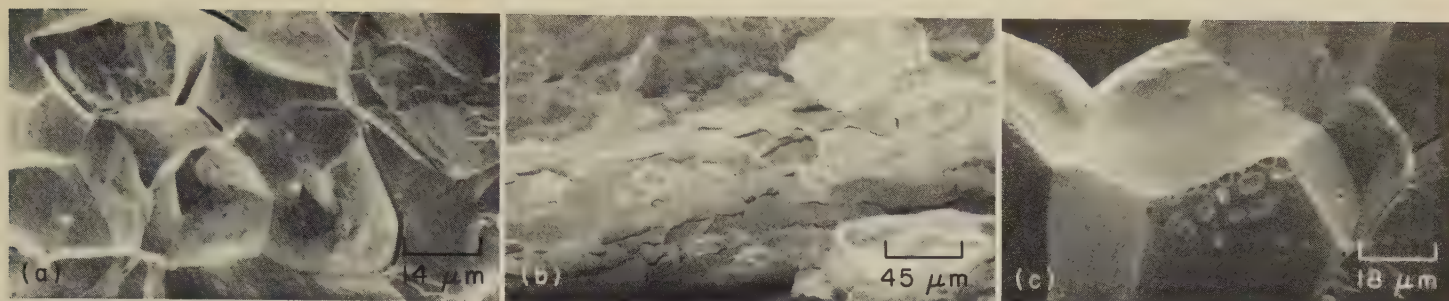
Fig. 22. Intergranular brittle fractures in tungsten, iridium, and a tungsten - 3 wt % rhenium alloy

(a) Sintered tungsten rod drawn to 0.060-in. diam, recrystallized at 10^{-6} torr and 2600 C (4712 F) for 100 hr, fractured in tension. (b) Iridium sheet annealed for 50 hr in purified helium at 1700 C (3092 F), broken by bending.

to the microvoids or "bubbles" that are visible on the fracture surface (Fig. 22c).

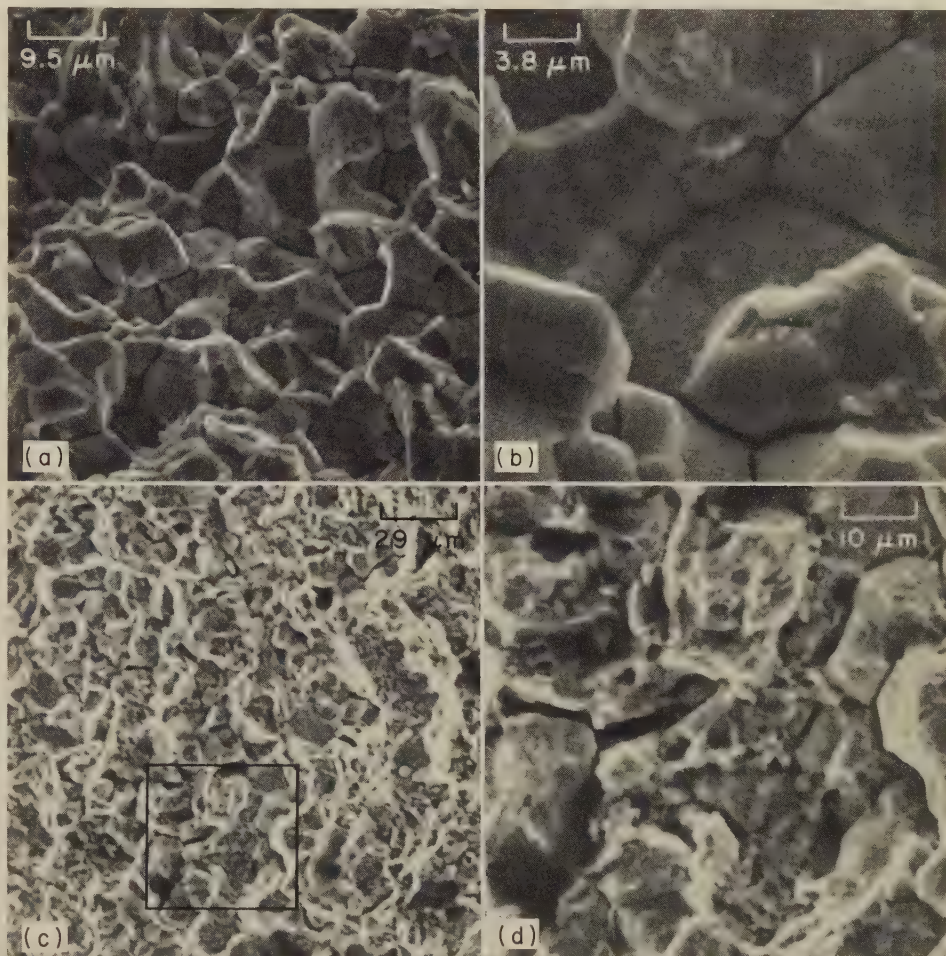
(a) and (b). Low and high-magnification fractographs of a 4340 steel test specimen that fractured at 75% of its yield strength due to hydrogen embrittlement following exposure to a 2% NaCl solution. (c) and (d). Two fractographs of the fracture in a

1050× (a); 2600× (b); 350× (c); 1000× (d) cadmium-plated helicopter rotor of 4340 steel (with vanadium added) after exposure to a marine environment. The outlined region in (c) is shown at a higher magnification in (d). Corrosion products are visible on the separated-grain facets.

With hydrogen embrittlement, intergranular fracture can occur as shown in Fig. 23. Fracture can occur early under sustained loading if the metal was previously embrittled, or it can result from progressive embrittlement in salt air under service loadings. Depending on the environment, the fracture surface may display greater or lesser amounts of corrosion products.

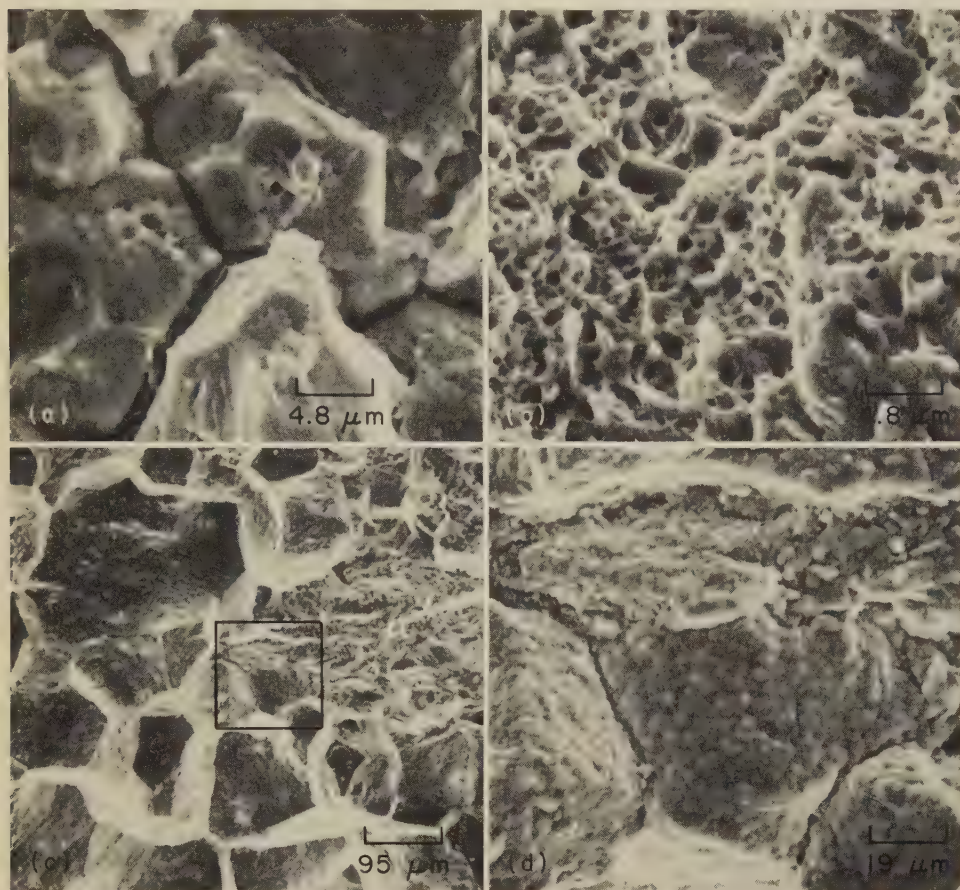
Fig. 24. Intergranular stress-corrosion fractures, and a region of transgranular fracture induced by stress-corrosion cracking

(a) and (b). Fracture in a 300M steel aircraft landing gear that resulted from stress-corrosion cracking. The stress-corrosion-cracking portion of the fracture is intergranular, as shown in (a). Beyond the corrosion penetration, the fracture induced by the cracking is transgranular dimpled rupture, as shown in (b).

(c) and (d). Fracture in a U-700 turbine blade. Fracture is presumed to have been the result of combustion-gas attack, which induced stress-corrosion cracking. The region outlined by the rectangle in (c) is shown at a higher magnification in (d), which makes the corrosion products on the separated-grain facets more easily seen.

Intergranular fracture also results from stress-corrosion cracking, as shown in Fig. 24. Corrosion products are frequently observed on the separated-grain facets of stress-corrosion cracks (Fig. 24d). Often the intergranular mechanism will be active in only a portion of the fracture if penetration by stress corrosion is only partial. Beyond the corrosion penetration, there will be evidence of ductile fracture by microvoid coalescence, as shown in Fig. 24(b).

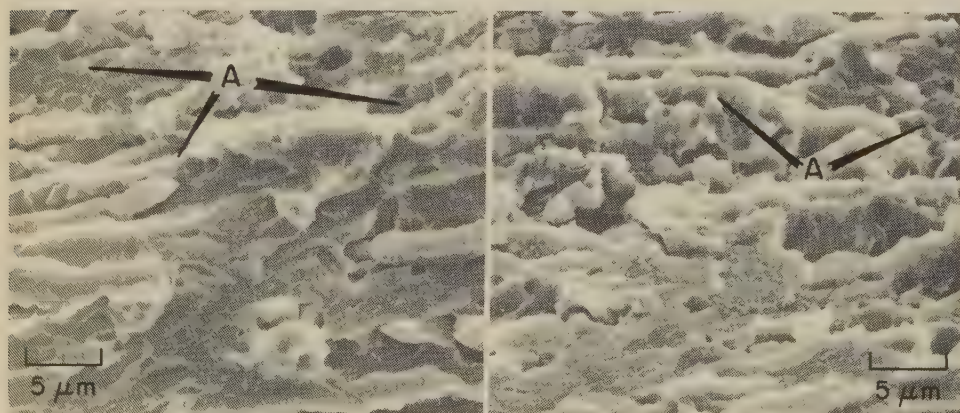
Fig. 25. Intermingled cleavage facets and dimples in two views of a stress-corrosion fracture in a step-cooled two-phase Ti-6Al-2Sn-4Zr-6Mo alloy exposed to a 3½% NaCl aqueous solution. Cleavage facets formed in the alpha phase, and poorly developed dimples, such as at the sites marked A, formed in the beta phase.

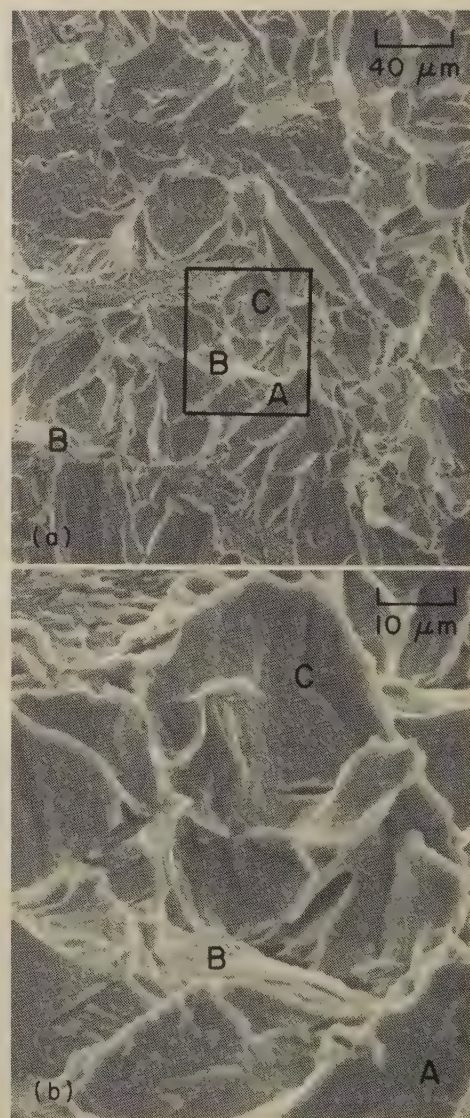
Fig. 26. A fracture formed mainly by cleavage and tearing in unalloyed titanium

The region outlined in fractograph (a) is shown at higher magnification in fractograph (b). Cleavage facets are visible, such as at A, separated by areas of tearing, such as at B. A number of large, smooth facets, such as at C, are believed to have been caused by plastic shear. The area of tearing, B, in fractograph (b) could be mistaken for fatigue striations.

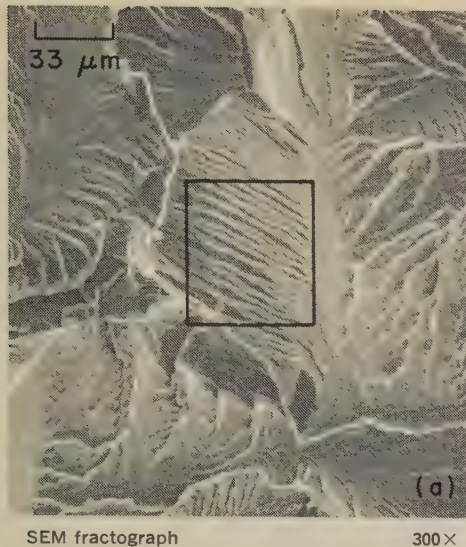
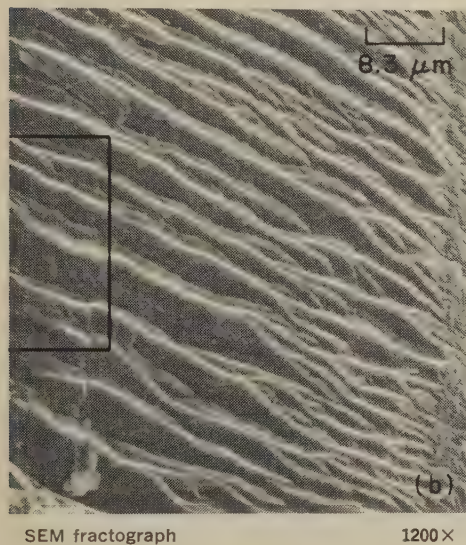
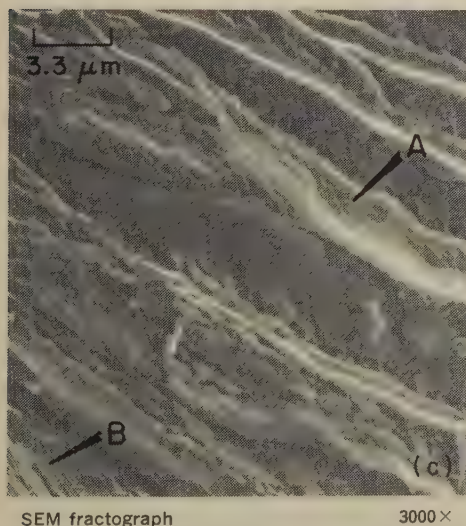
Fig. 27. Fracture surface of an alpha titanium alloy showing regions of cleavage facets interspersed with minute regions of fatigue striations that are visible only at high magnification

Essentially all of the features in (a) are cleavage facets with highly developed river patterns of cleavage steps. In (c), very fine fatigue striations can be detected between cleavage steps, as at A and B. The outlined regions in (a) and (b) are shown at higher magnifications in (b) and (c), respectively.

Cleavage plus fatigue-striation formation is observed in high-strength, low-ductility metals and in metals of lower crystallographic symmetry (see the fracture in alpha titanium in Fig. 27). Those grains that are favorably oriented with respect to the cyclic stress axis fracture by sudden cleavage, and those oriented to relax the load by cyclic plastic relaxation fracture incrementally by fatigue.

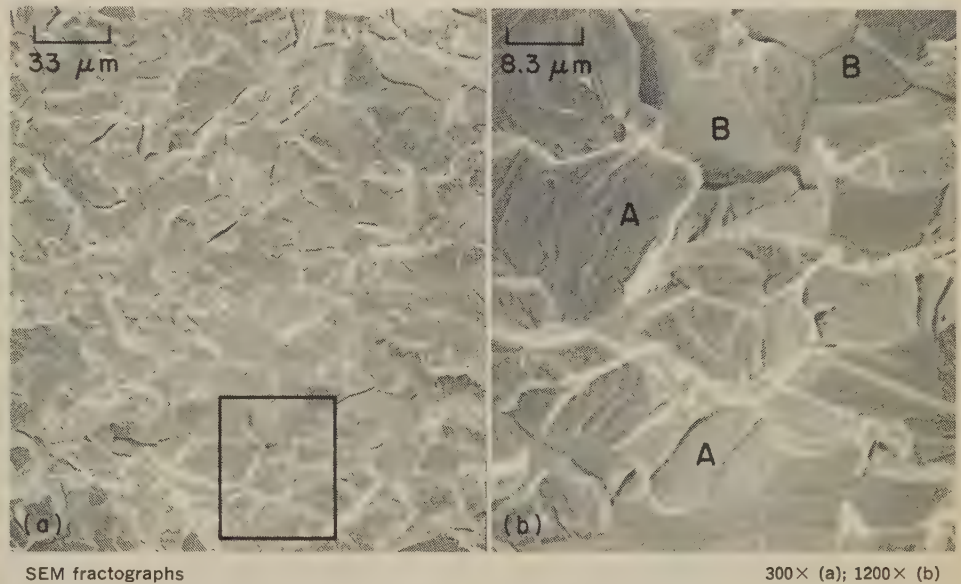
Fig. 28. Combined cleavage and intergranular fracture in alloy Cb-752 (Cb-10W-2.5 Zr) containing 750 wt ppm of oxygen

This fracture surface is largely made up of cleavage facets, as at the sites marked A in fractograph (b), but intermingled with the cleavage facets are intergranular fracture surfaces, as at the sites marked B. The outlined region in fractograph (a) is shown at higher magnification in fractograph (b).

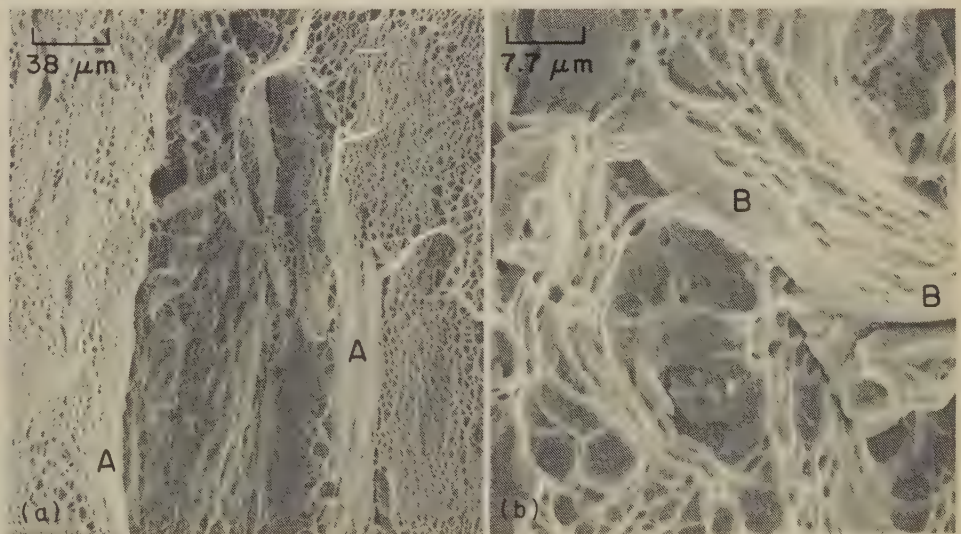
Fig. 29. Fracture surface resulting from microvoid coalescence plus tearing of a tensile-test specimen of Ti-8Mo-8V-2Fe-3Al that had been quenched from 900 C (1652 F) and aged 144 hr at 350 C (662 F)

This fracture surface contains a mixture of dimples (much in the majority) and regions of tearing. Fractograph (a) shows extensive regions of dimples adjacent to two tear ridges, marked A. Fractograph (b), at a higher magnification, shows details of regions of tearing, marked B, adjacent to dimpled regions.

form of this mixture of fracture mechanisms. This type of fracture occurs frequently in two-phase metals such as titanium alloys, where one phase is susceptible to fracture by tearing. An example of a combination of these fracture mechanisms is shown in Fig. 29.

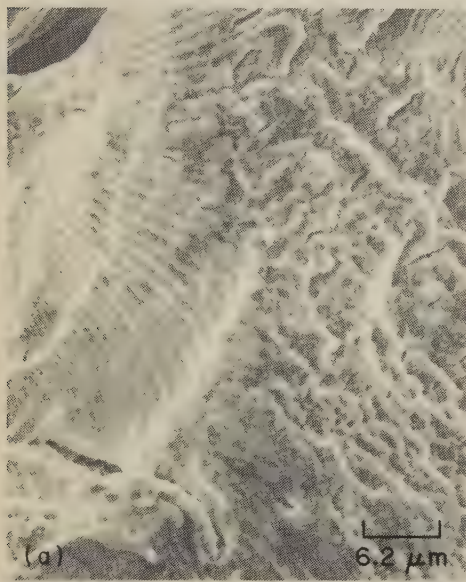
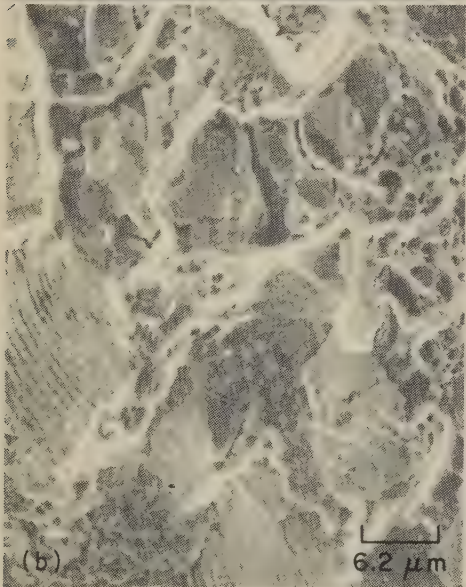
Fig. 30. Intermingled dimples and fatigue striations in low-cycle fatigue-test fractures in aluminum alloy 2024-T851 at a high range of stress intensity (ΔK) at crack tip

SEM fractographs Both at 1600×
Orientation of fatigue striations differs from patch to patch, particularly in fractograph (a). Dimples in fractograph (b) are associated with inclusions.

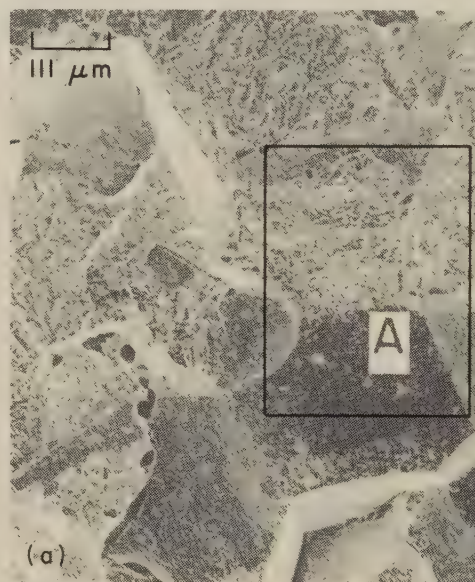
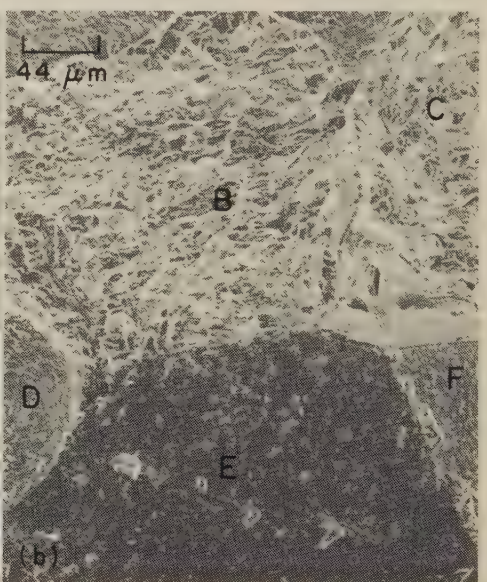
Fig. 31. Mixture of dimples and intergranular fracture surfaces in a fracture in a 3340 steel specimen that had undergone incomplete reversible temper embrittlement

SEM fractographs 90× (a); 225× (b)
Fractograph (b) is a higher-magnification view of the outlined region at A in fractograph (a). It displays regions of dimples formed by microvoid coalescence, such as those at B and C, interspersed with regions of intergranular fracture surfaces, such as those at D, E and F.

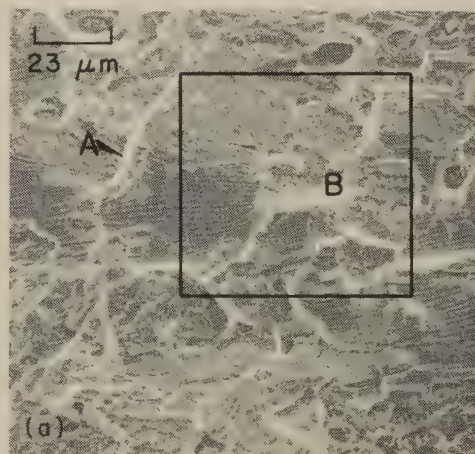
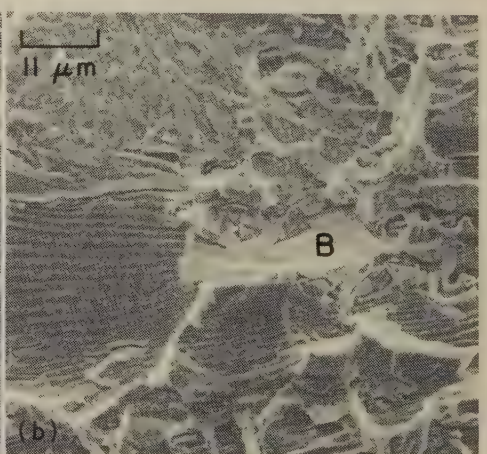
Fig. 32. Fracture surface showing mixed tearing and fatigue-striation formation in a fatigue-test specimen of aluminum alloy 7075-T6

SEM fractographs 440× (a); 880× (b)
In fractograph (a), tear ridges can be seen between fatigue-striation patches, as at arrow A. Fractograph (b) is a view at higher magnification of the region outlined by the rectangle in (a). Also present are broader areas of tearing, such as at B, that have some resemblance to glide-plane decohesion or stretching.

Tearing plus fatigue-striation formation is a common type of fracture. It occurs at cyclic stress-intensity levels that approach the K_{Ic} of the metal. That is, intermixed regions of ductile tearing and striations are often seen in fatigue specimens with crack depths approaching that which corresponds to catastrophic fracture. The local variations in fracture type are probably related to local variations in grain orientation. For example, one grain may fracture by fatigue whereas an adjacent grain may be so oriented that it sustains heavy shear-band formation and fractures by tearing. The next grain may fracture by fatigue, leading to the mixed mechanisms shown in Fig. 32 and 33.

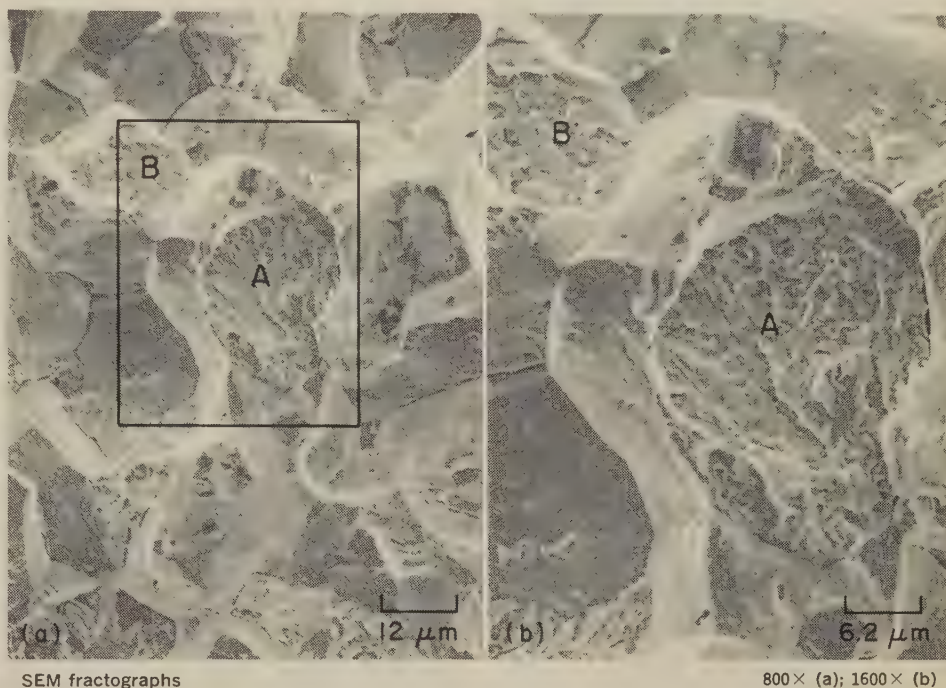
Fig. 34. Fracture surface through the fully hardened case of a carburized low-alloy steel, showing a mixture of tearing and intergranular separation

The combination of strain rate and temperature was conducive to the fracture of some grains by tearing, as at A and B, in a fracture that otherwise was very definitely intergranular. Fractograph (b) is a higher-magnification view of the outlined region in fractograph (a). The transgranular facets at A and B show light-toned lines that are presumed to be tear ridges.

hibit intergranular fracture in the fully hardened case. In these materials, particular combinations of such factors as strain rate and temperature can promote the fracture of some grains by tearing. An example of such a mixed-mechanism fracture is shown in Fig. 34. Other metals in which mixed intergranular fracture and tearing have been observed are hydrogen-embrittled Monel (see Fig. 35) and temper-embrittled steel. In these metals, the occurrence of this mixture of fracture mechanisms indicates a degree of embrittlement lower than that which would lead to completely intergranular fracture. This lower degree of embrittlement might result from a less severe environment (low hydrogen pressure) in hydrogen-embrittled Monel, and from incomplete grain-boundary segregation in temper-embrittled steel.

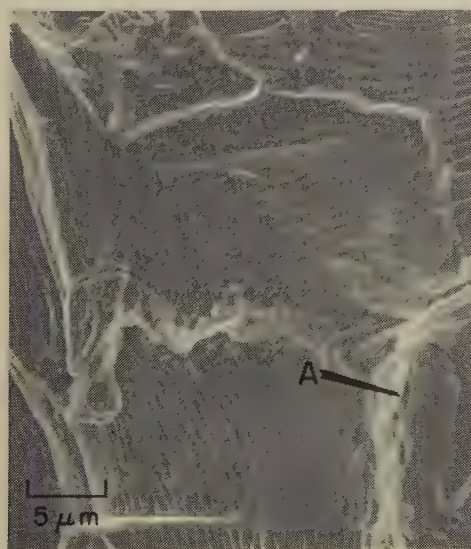
Fig. 33. Fracture surface of a fatigue-test specimen of unalloyed titanium, showing patches of fatigue striations separated by narrow tear ridges, as at A. The pronounced variations in striation orientation indicate local changes in the direction of fatigue-crack propagation.

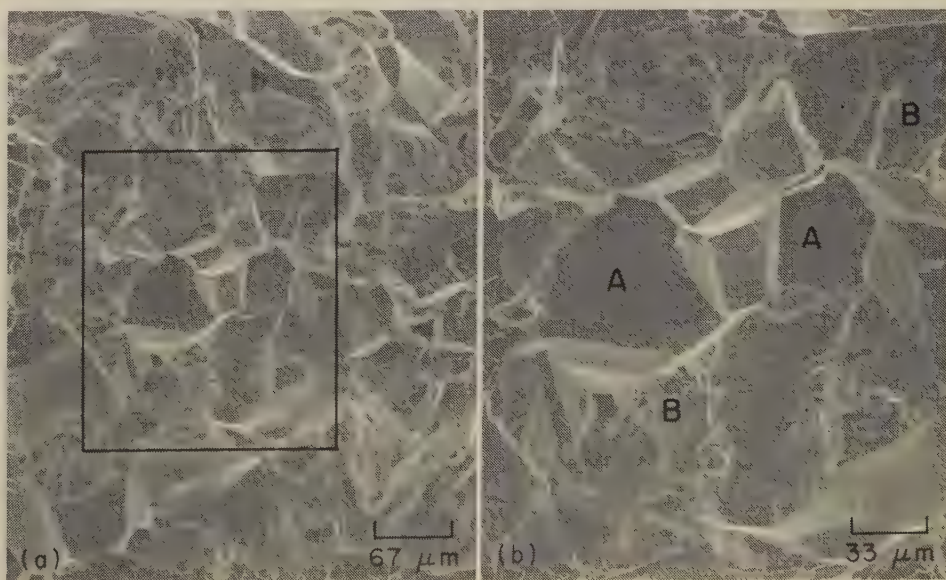
Fig. 35. Fracture surface of a Monel specimen, showing a mixture of tearing and intergranular fracture. Specimen was fractured in a gaseous hydrogen environment.

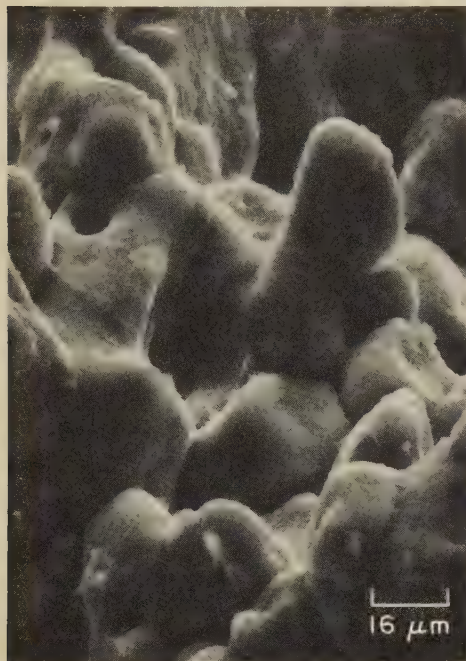
Fig. 36. Fracture surface produced by stress rupture in an aluminum alloy 1100 tube stressed at 3.45 MPa (500 psi) at a temperature at or near the melting point of the alloy

Grains are elongated and have rounded edges. They lack the usual flat grain facets seen in room-temperature intergranular fractures. The grain surfaces show evidence of oxidation, which must have occurred at the elevated temperature during and after final fracture.

propagate along the grain boundaries, resulting in intergranular cracking. As an example of a high-temperature fracture of this type, Fig. 36 shows a fracture surface of an aluminum alloy 1100 tube that fractured at a temperature at or near its melting point. Separation occurred along the grain boundaries. The grains are elongated and their edges are rounded.

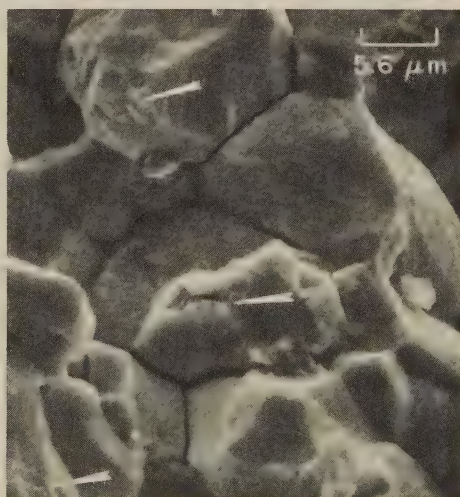
SEM fractograph

1800×

Fig. 39. Intergranular stress-corrosion fracture in vanadium-modified 4340 steel that occurred after exposure to a salt-water environment. Secondary intergranular cracks nearly surround some of the grains. The fracture is almost 100% intergranular except for local regions (see arrowheads), where some evidence of ductile fracture exists.

Stress-Corrosion Cracking and Hydrogen Embrittlement. Fractures in quenched-and-tempered high-strength steels by stress-corrosion cracking and hydrogen embrittlement are intergranular when the stress intensity at the tip of the propagating crack is low. The fracture path is along prior austenite grain boundaries, and the fine detail revealed on the grain facets can be related either to plasticity effects associated with the fracturing process or to corrosion effects associated with certain aqueous environments, when these are present. The intergranular fracture that developed in a vanadium-modified 4340 steel that had been exposed to a salt-water environment is shown in Fig. 39. The highly crystalline surface shows very little transgranular cracking, and no indication of the existing martensitic structure is evident. The grain facets show evidence of some ductility during fracture, but it is confined to the extremely narrow regions of the grain boundaries. Secondary cracking normal

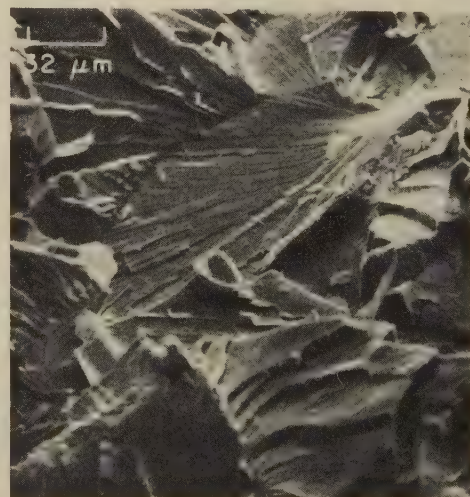
SEM fractograph

315×

Fig. 40. Transgranular stress-corrosion fracture in a pressure vessel of type 316 stainless steel that broke after extended exposure to a chloride-containing environment at elevated temperatures and pressures. Individual grains are outlined by changes in direction of local cleavage. River patterns in facets are separated by tear ridges.

The fracture path resulting from stress-corrosion cracking can be either intergranular or transgranular. The same alloy system will often show both types of fracture, depending on the state of cold work, heat treatment, or other variable. One such alloy system is the austenitic stainless steels. Exposure of these alloys to aqueous environments containing chloride ions often results in stress-corrosion cracks that propagate in a highly branched system of transgranular cleavage cracks. Figure 40 shows the fracture topography resulting from a service fracture of a pressure vessel made of type 316 austenitic stainless steel. The vessel cracked after extended use in chloride-containing atmospheres at elevated temperatures and pressures. The fracture is completely transgranular. Individual grains are delineated by changes in crack elevation and propagation direction. The flat cleavage facets exhibit river patterns and tear ridges, which developed as the various cracks joined.
